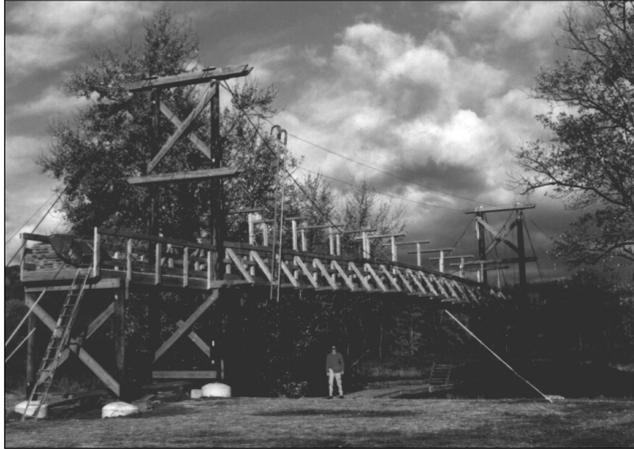
Photo 82. Bridge prior to decking and stairs. *Photo courtesy of Mr. Tibor Latincics.*

underside of the 6-inch by 6-inch cross-stringer. This is detailed on Plan Sheet 8, Figure 16 (page 59), and photo 64 (page 62). As each threaded rod adjustment affected the load on its neighbor, the final bridge tuning was a repetitive process. Photo 82, perhaps the definitive photo during the construction period, shows the bridge camber after two adjustments.

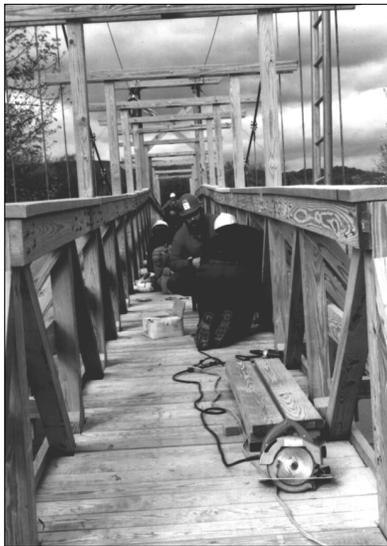
The plans specified 2-inch by 6-inch #1 SYP CCA.40 KDAT 19% MC decking, screwed down bark side up with a 1/8-inch gap between boards to accommodate swelling. The screw holes were pre-drilled, and the soaped square drive, galvanized 3-inch bugle head deck screws were driven two per joist at 14.5 inches on center (o.c.) This was a very time-consuming process as opposed to power nailing. This is shown in photo 83. Out of the 31 other pedestrian suspension bridges inventoried by the author, only the Dry River Bridge in the WMNF used screws; all others were nailed. Screws are a superior connector, especially for an elevated bridge subject to cross-winds.

Photo 83. Chris Mazza and other Trail conference volunteers screwing down the walkway 2-inch by 6-inch decking. *Photo courtesy of Mr. Tibor Latincics.*

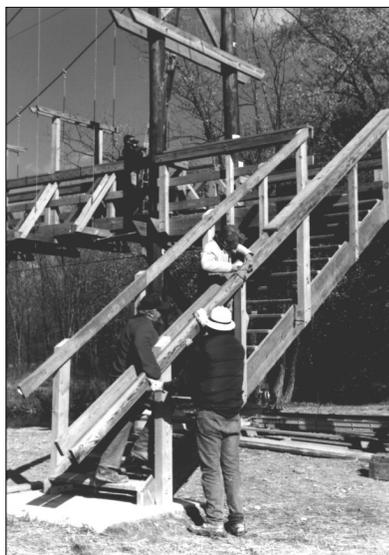
Photo 84. East side staircase construction. *Photo courtesy of Mr. Tibor Latincics.*

The staircases are detailed on Plan Sheet 3, and the construction is shown in photo 84. When the wire mesh and handrail are completed, the staircases will comply with the BOCA® code, with the exception that the total rise on the west staircase is 12 feet, 3 inches, which is 3 inches more rise than allowed by BOCA® without an intermediate landing. Given the location on a wilderness footpath, the project partners and project owner found this to be acceptable.
